SECTION: 307-01

Rattling/Vibrating Noise From Underneath The Vehicle When Driving On An Uneven Road Surface

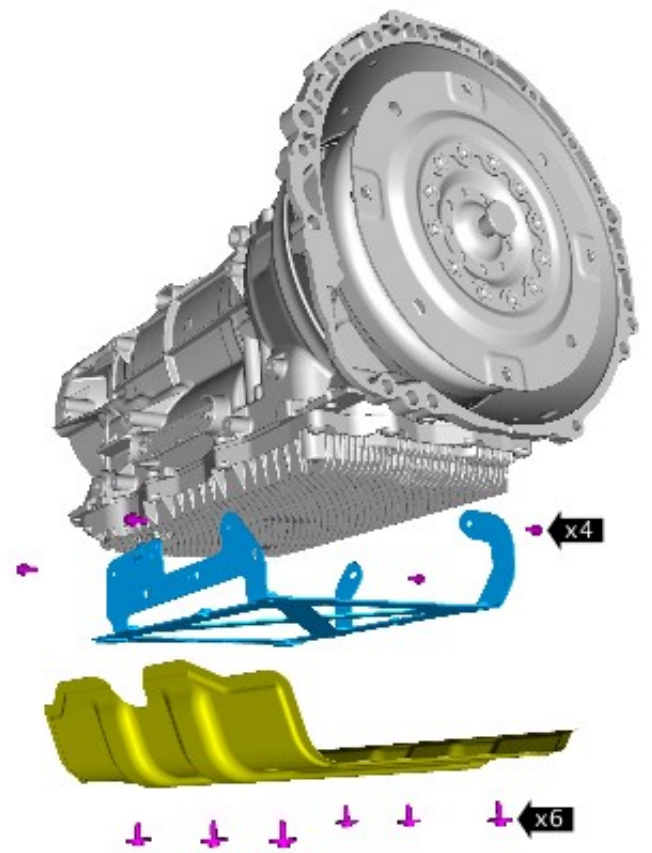
E175513

Cause: A cracked transmission heat shield mounting bracket. **Suggested Customer Concern Code - MQ3.**

2 Remove the transmission heat shield mounting bracket.

- Torque: 9 Nm
