# TECHNICAL BULLETIN

No: LA-501-015  
Issue: 1  
Date: 22 FEB 2006

## Exterior Rear View Mirror Glass

#### DOOR MIRROR GLASS RATTLE

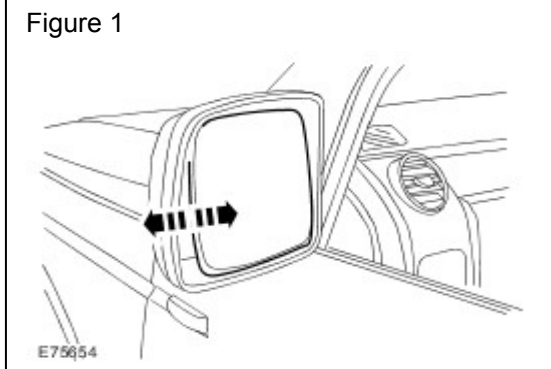
1. Manually move the affected RH and/or LH exterior rear view mirror glass to its fully inboard position.
2. If unsecured movement of the glass is found in the direction shown proceed to step 3. (Figure 1)

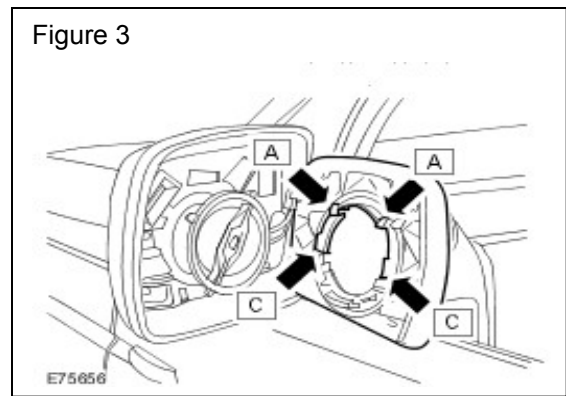
Figure 3

**NOTE:** The two locating ribs, identified as 'C' may fracture during mirror detachment. This is normal and does not affect the reinstallation, retention or function of the mirror glass and should not be replaced. (Figure 3)

- Lift the glass upwards to disengage the two clips 'A' from the motor. (Figure 3)

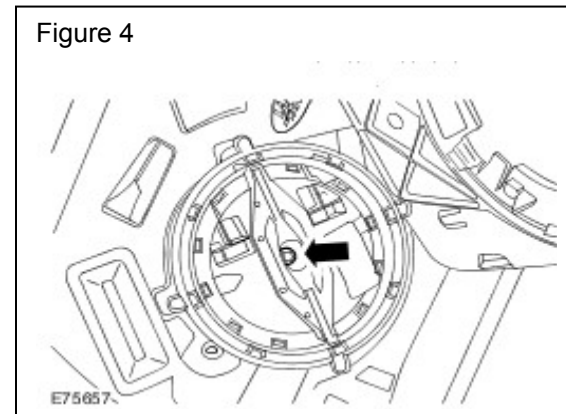
Figure 4

**Cause:** Mirror manufacturer build process resulted in an incorrect mirror motor alignment, prior to the installation of the motor retaining screw. When the mirror glass is installed to the mirror assembly, the motor is clicked into its correct location, relieving the applied torque of the motor retaining screws.

4. Ensure the motor is fully secured and located into correct position.
5. Centralize the motor and tighten the Torx screw to a **maximum** torque of 1.0 Nm (8.5 in-lb). (Figure 4)
