TECHNICAL BULLETIN

LTB00154v3

Squeak From Steering Gear

Discovery 3 / LR3 (LA)

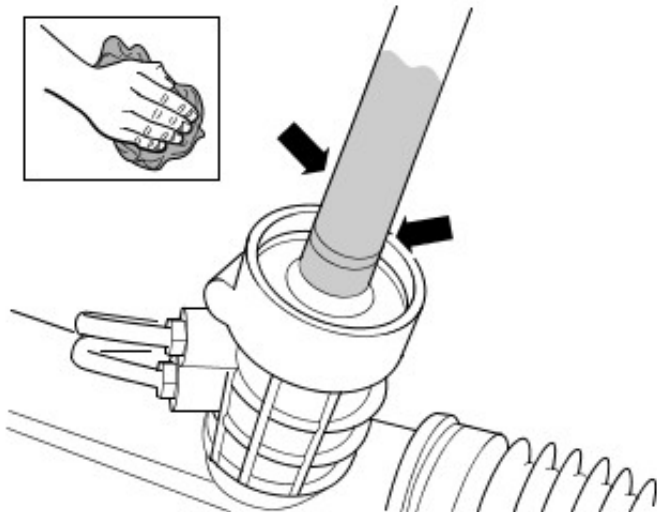
E104317

**NOTE: If any gouge/scratch or damage has occurred to the internal surfaces of the housing, then a new steering gear must be installed.**

Clean the pinion shaft and verify that no damage has occurred to the pinion diameter whilst removing the seal.
