# TECHNICAL BULLETIN

LTB00661v2  
30 OCT 2014

### 3rd Row Seat Will Not Fold Or Sticks In Operation

##### **Discovery 3 / LR3 (LA)**

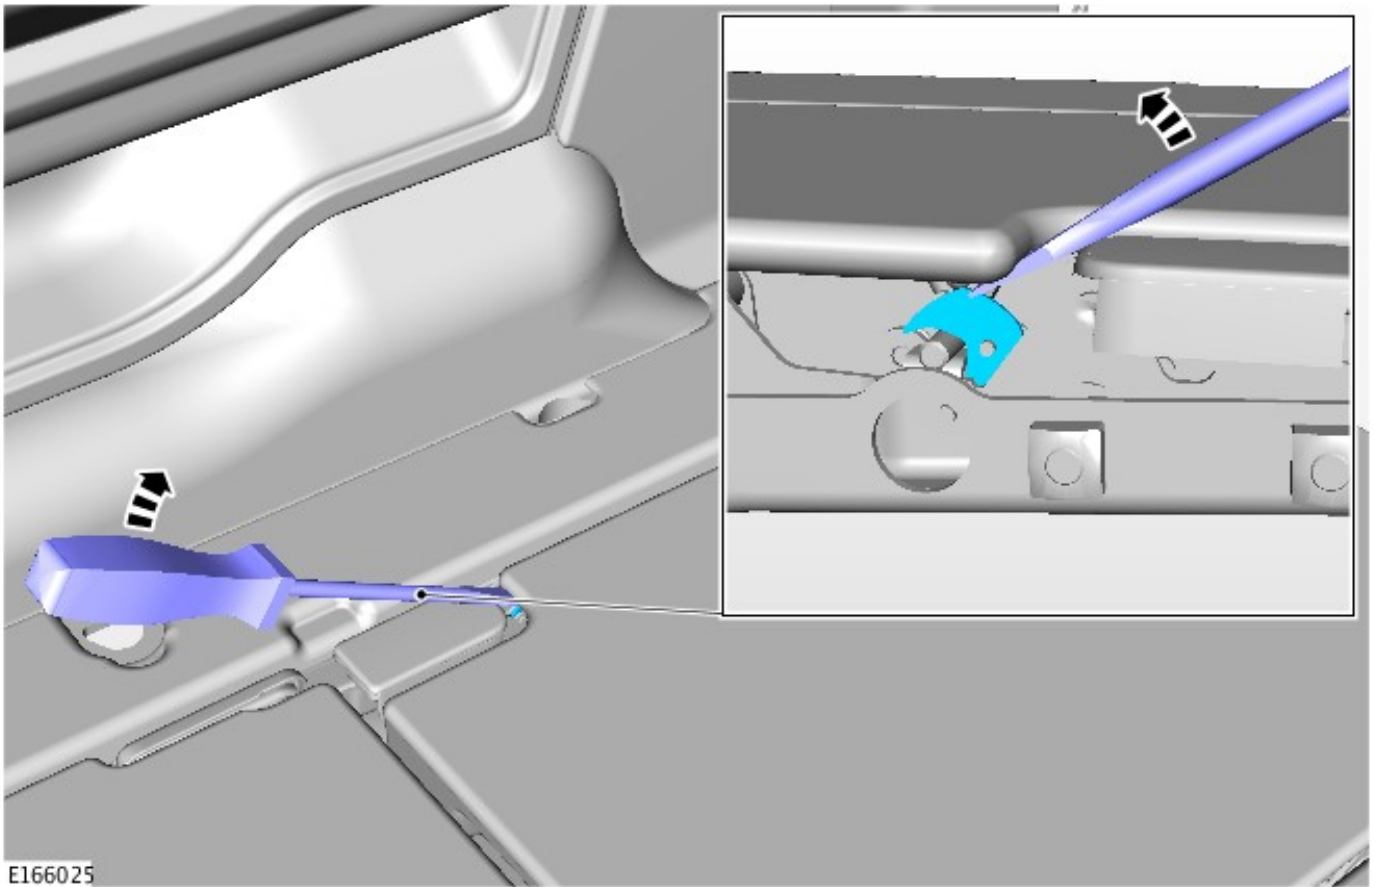
E166025

**Cause:** The seat operating lever is out of alignment.

- Using a suitable tool, release the 3rd row seat latch.

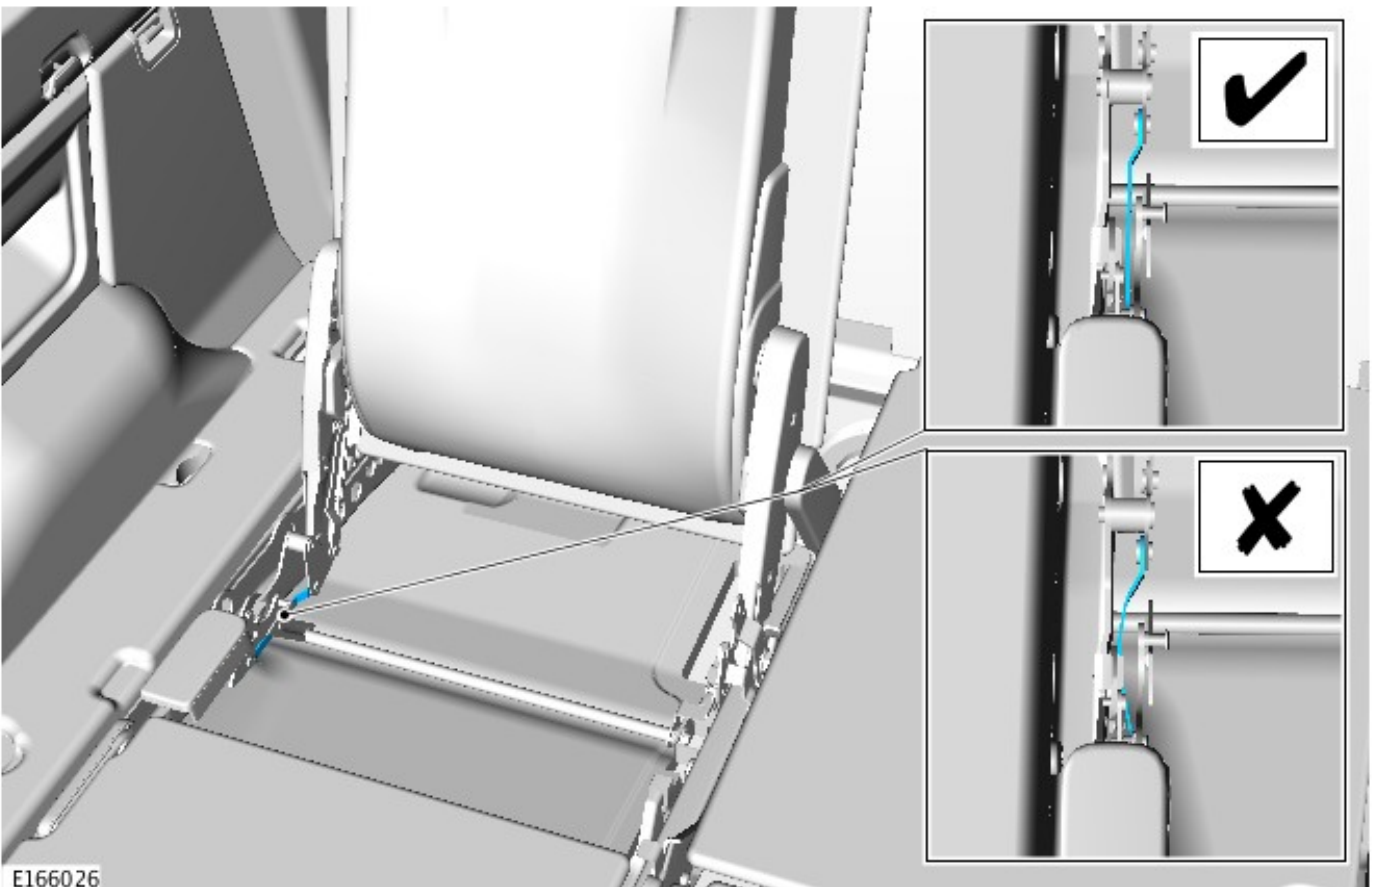
E166026

**2. Inspect the linkage.**

- Using a suitable tool, position the linkage to one side as shown.
