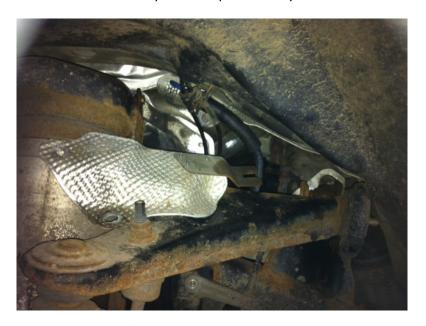
Removal of three heat shields necessary in front N/S wheel well. Take care noting exactly how they are removed to ensure they can be replaced easily

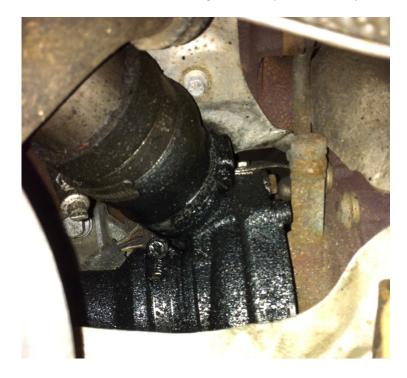
View of turbo area before being cleaned up and hose replaced

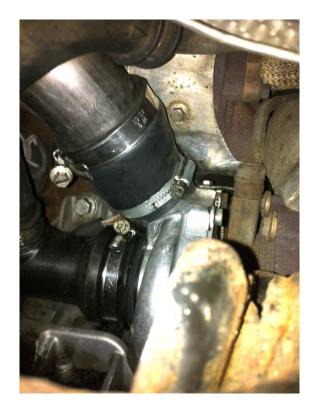
View of turbo clean up and hose replaced

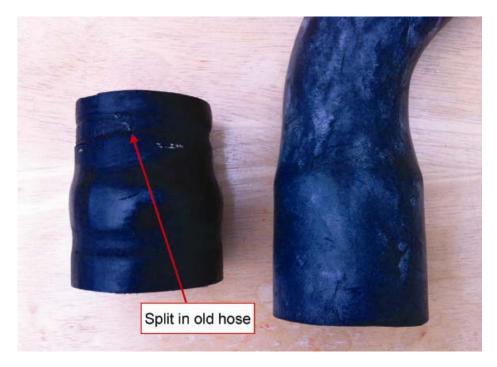
Old hose removed and section of new hose before trimming
