Replacing the blower motor LR3

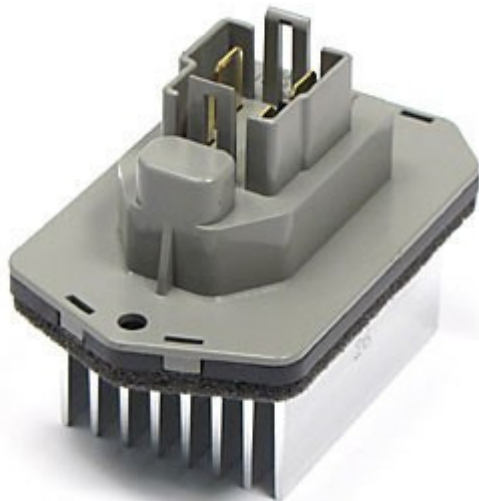
This is what the blower control module, part number LR031677, looks like.

Start with removing the rectangular blower control module resistor first, part number LR031677. It is held in with two Phillips head screws. One screw is a bit hard to get at but with the lower glove box door fully opened, you can see both screws and hence where to stick the Phillips screwdriver. I was able to pull the existing unit out and then release the electrical connector, but when I went to install the new one, it was easier to insert and screw in the module first and then push on the electrical connector.

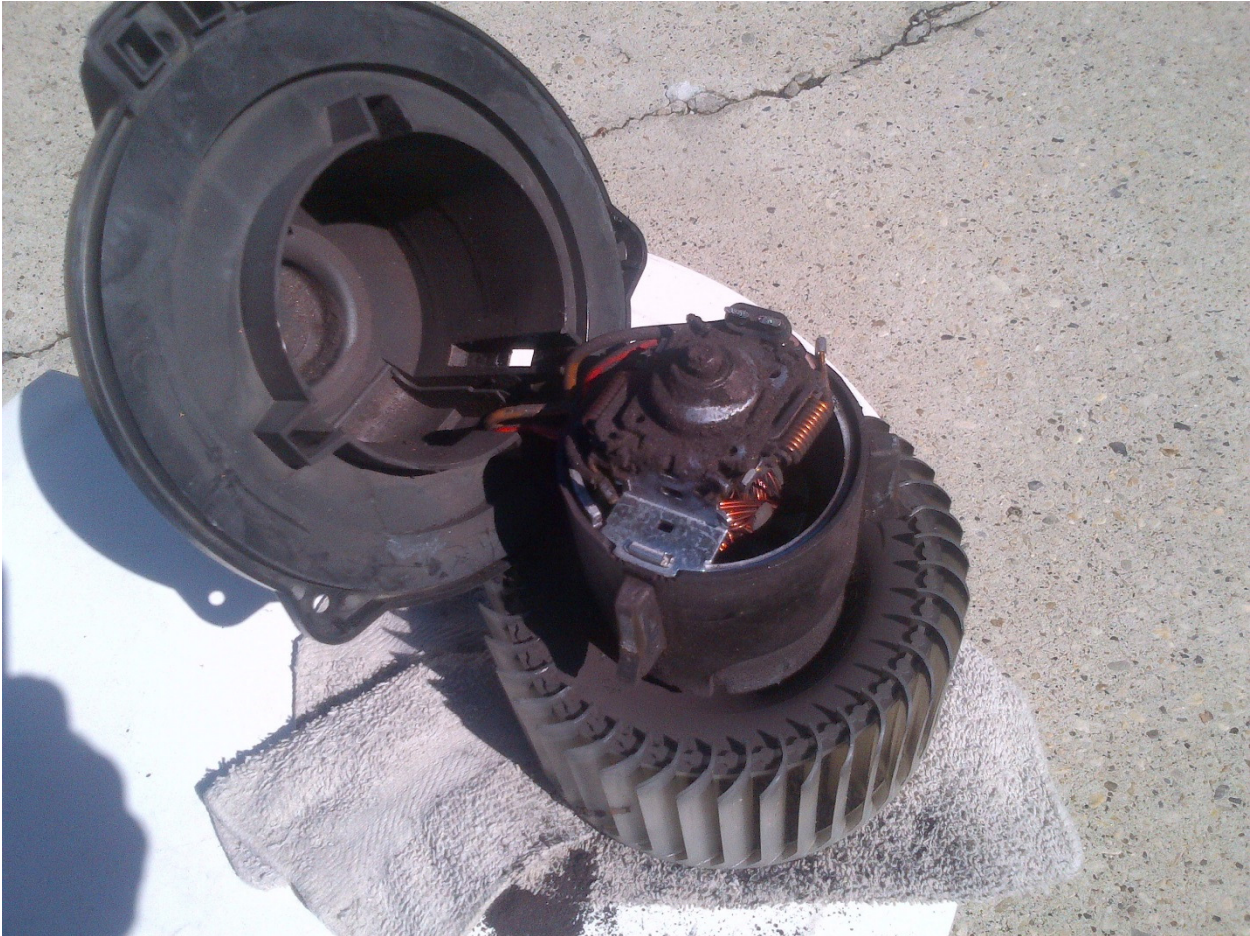
This is the fan with the "lid" removed showing the carbon.

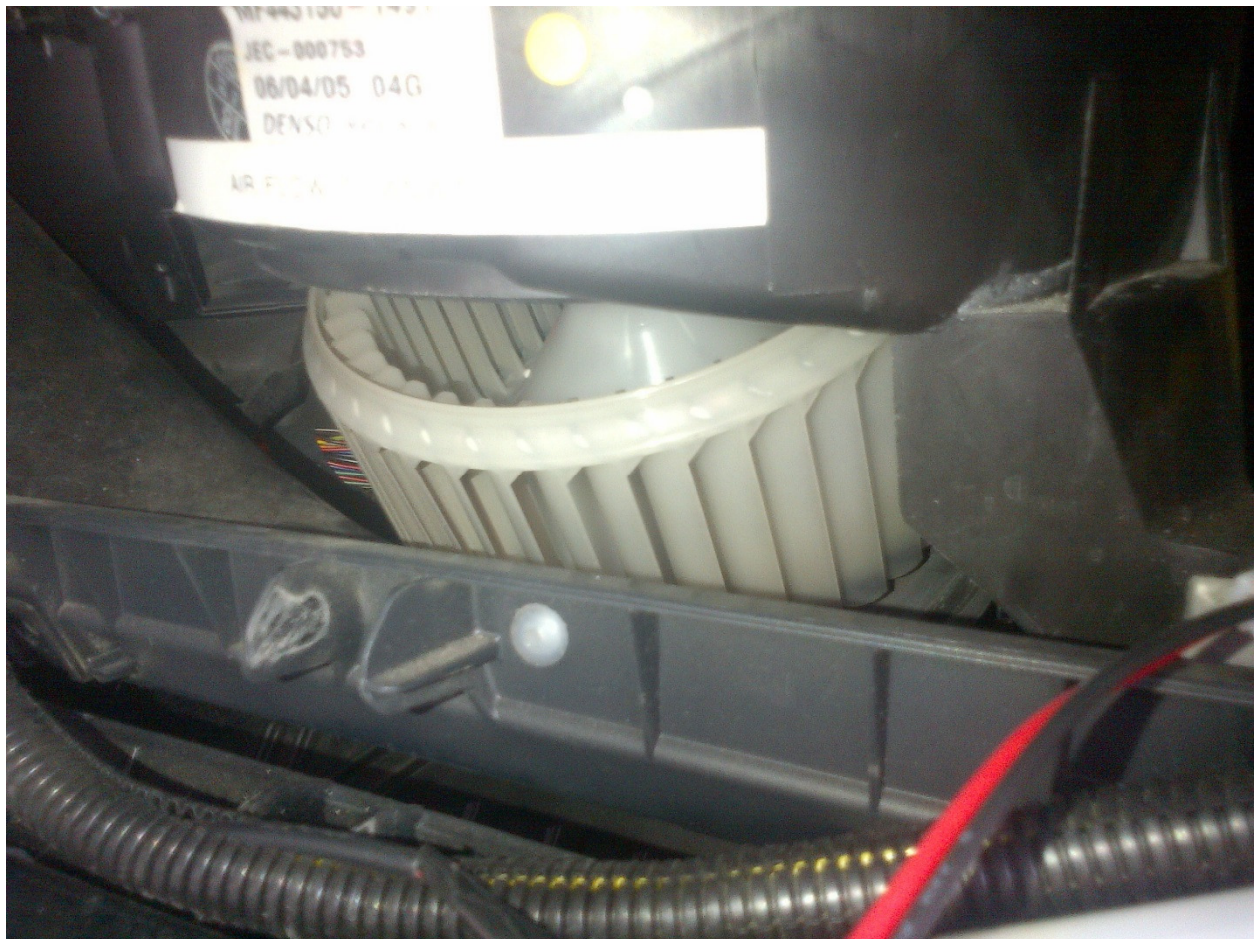
This is a view thru the opened and dropped lower glove box door. It shows the fan dropping down towards the carpet and out. In other words, one can remove and install the new fan without tearing the dash apart. There is an air duct that has to be twisted a bit – maybe 2mm or so.

The blower control module is also removed and reinstalled without any great fuss; it sits to the rear of the fan and can be replaced from under without removing the fan.

Once the wiring is disconnected and pushed aside, then the tricky bit of dropping out the fan assembly is next. This does not require any force, just lots of jiggling, rotating, and rocking about of the fan unit. The problem is an air duct that parallels the glove box door hinge. This duct will move, rotate slightly such that one fan will eventually slide out.

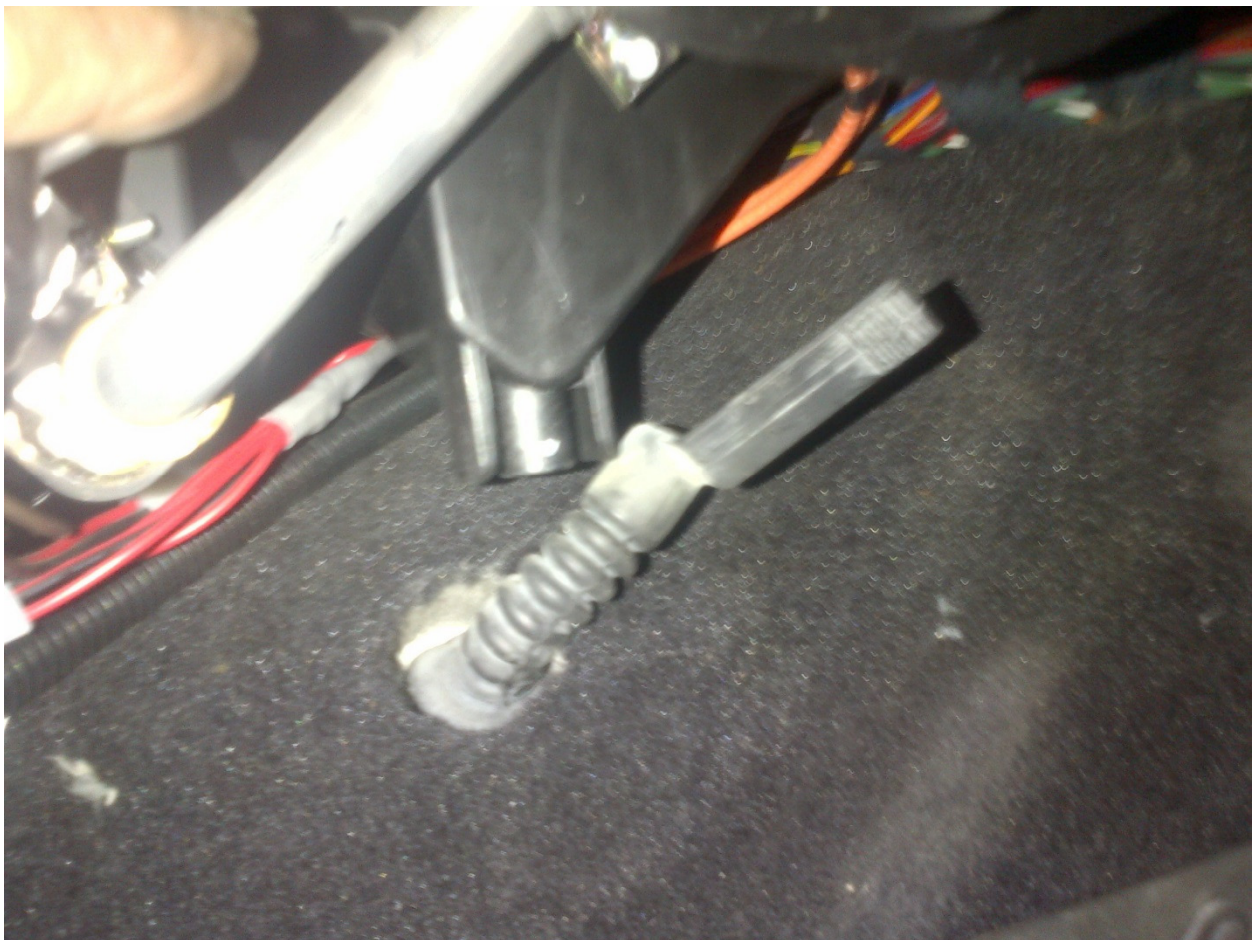
Below is one of the AC water drains that can come disconnected from the AC ducting nipples and hence “wet the carpet”. There are two of them, the other being on the driver’s side. The rubber just shrinks by itself, disattaches, and instead of the water flowing thru the floor boards onto the ground, it soaks into the carpet. It is not only AC condensation water but also rain or car wash water that can get into the system and hence is supposed to flow thru the drains.

Mine is a LHD North America spec, LR3 so on the passenger right side, first remove that insulated sound shield that holds the footwell light - basically two cross type Phillips screws and then disconnect the power lead to the footwell light - just pull back on it. Once removed, you may as well check to see if the AC drain is connected to the cowl drain. Mine was, but the jpg below shows it disconnected. The rubber hose just slides over the drain nipple - but I digress.
