Rear tailgate actuator

Fitment of a backup feature to – hopefully – prevent a failure of the lower rear tailgate actuator. The writer accepts no liability for wrongful or incorrect advice, or future failures

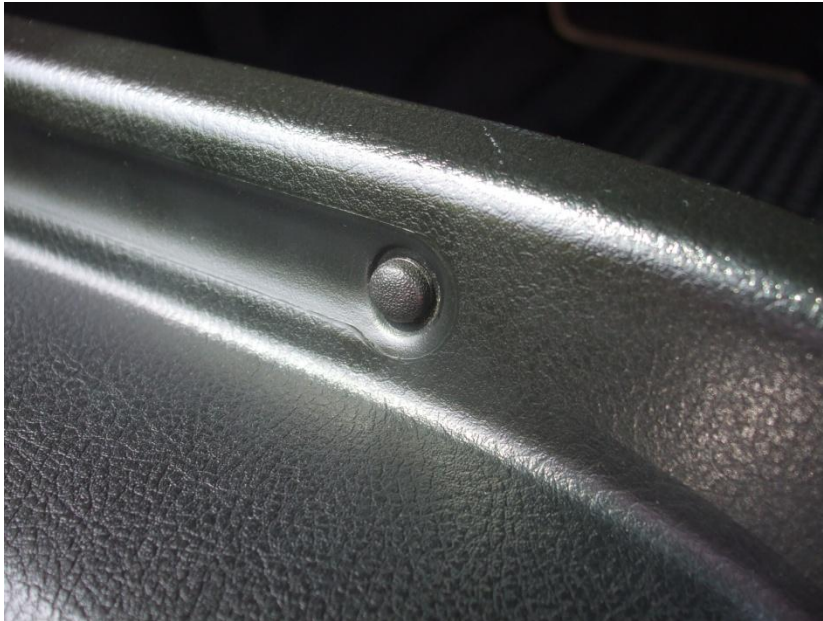
Open the upper tailgate and remove the four caps covering the screws on the black trim with a small screwdriver

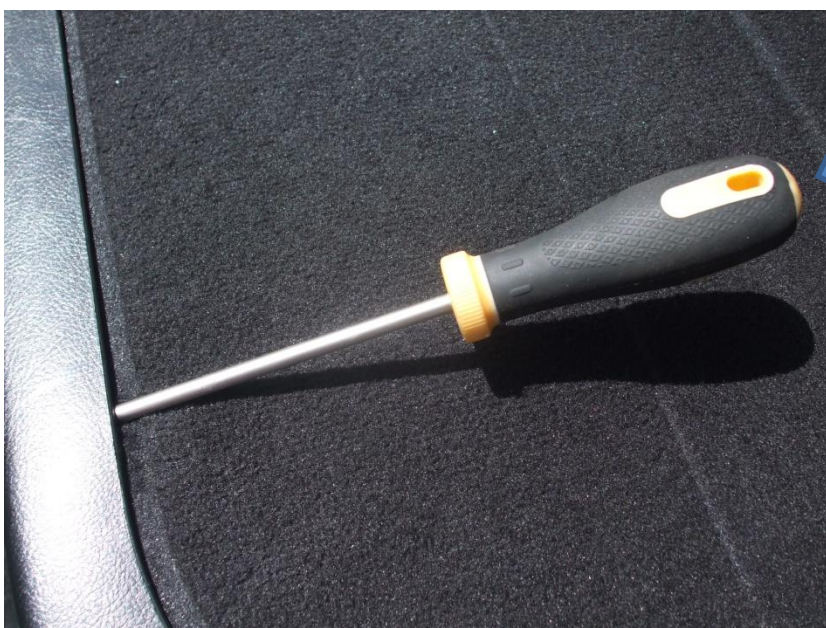
Remove the four pozidrive screws. The trim needs to be removed; open the tailgate and insert a large flat-blade screwdriver under the trim close to where the four screwholes are. Tap the end of the screwdriver handle and the trim should release and pop off. Work along the trim pushing the screwdriver under the trim in the four locations of the screws

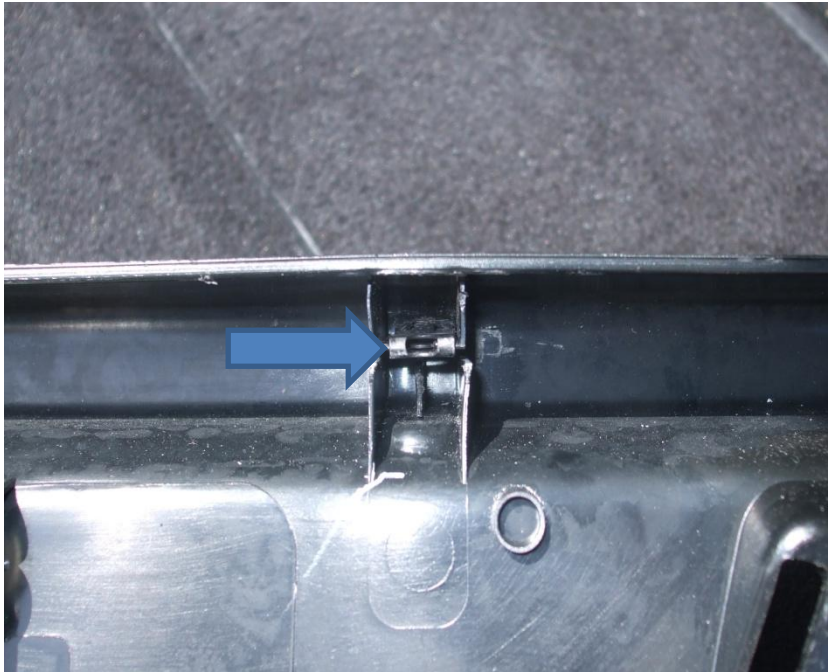
This is what the inside of the trim looks like; ensure that the captive clips remain in place and haven't fallen out. They provide the thread for the four self-tapping screws

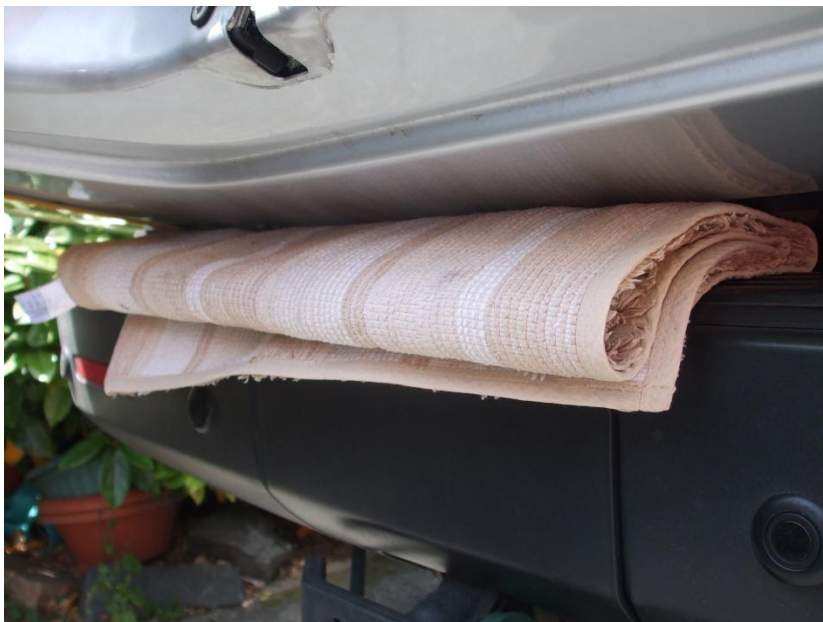
The carpet panel from the rear of the tailgate now needs to be removed. This involves disconnecting the supports on each side; because of this the tailgate will have nothing to take its weight. One solution is to place something soft on top of the bumper; an old rolled up bathmat was used here

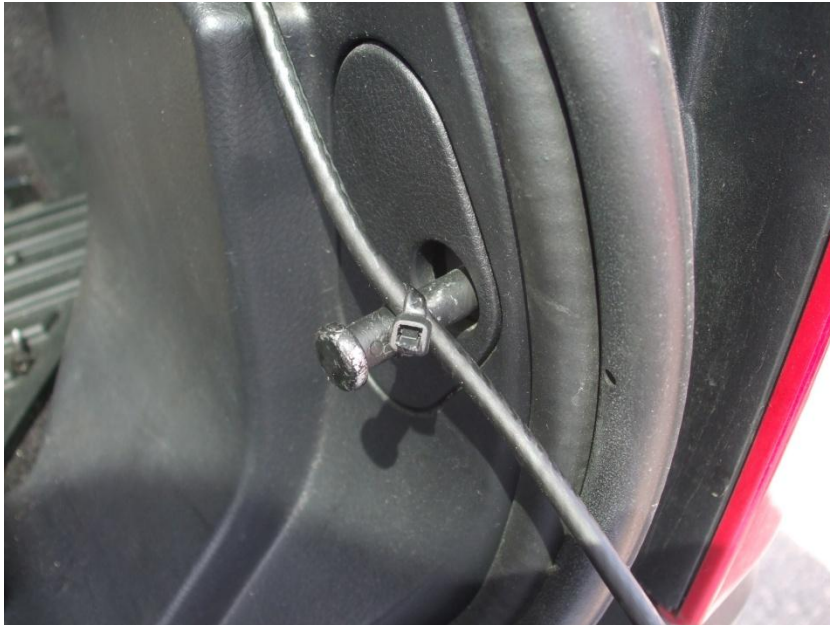
When the supports are disconnected they will disappear into the car and therefore wrap a cable tie or similar around the actuator pin

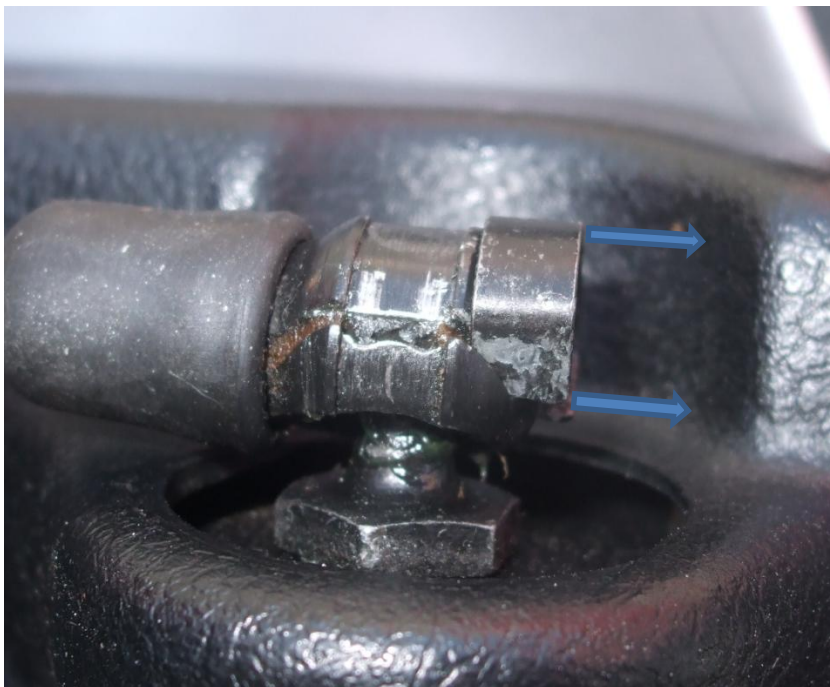
Slide the clip holding the end of the cable on the ball joint. Once at about the position shown below the socket should come away from the ball. Do this on both cables. Ensure that the weight of the tailgate is adequately supported to avoid damage – remember now that any downward pressure will have to be supported by what's been placed between the tailgate and the bumper

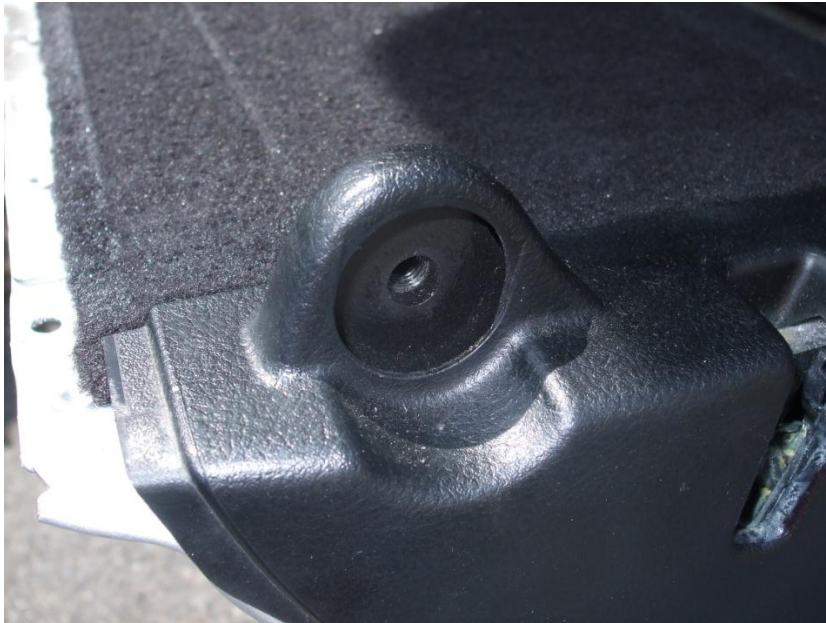
Remove the ball joints with a deep socket. The female thread is part of a metal bracket and therefore there's no nut etc to lose

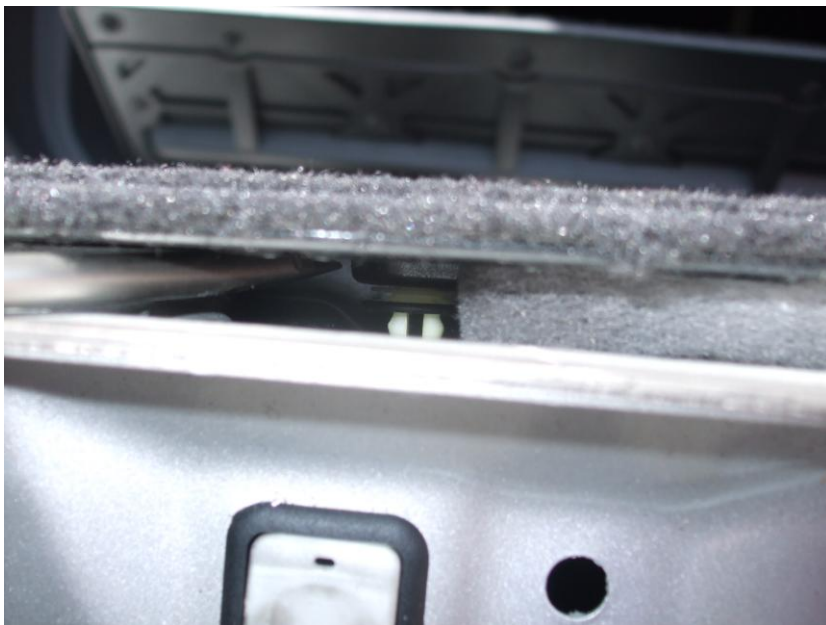
Pop the carpet off, there's ten clips around the circumference, the top edge can be prised up with a large screwdriver, the bottom can be pulled up.

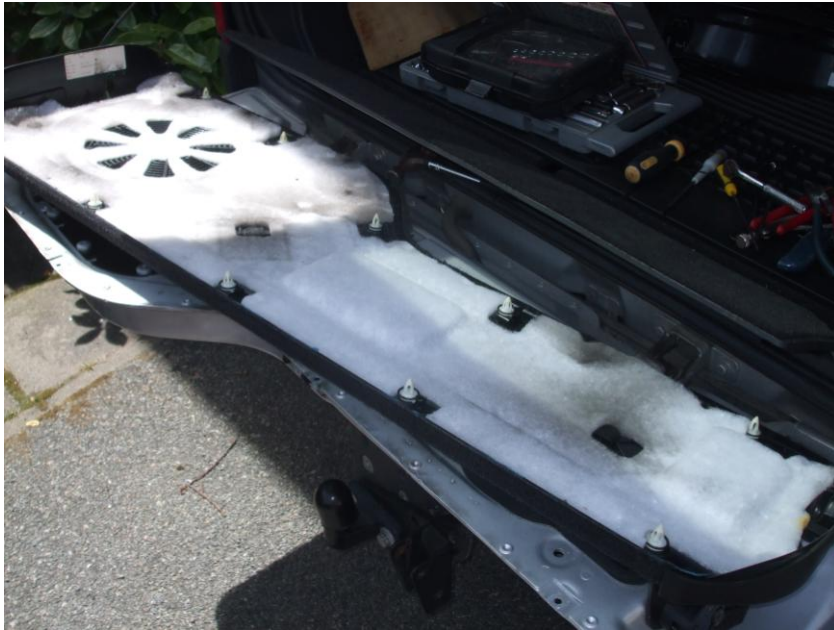
There are five clips along the top edge and five along the bottom. When prising or pulling up, try to pull up where there's a clip

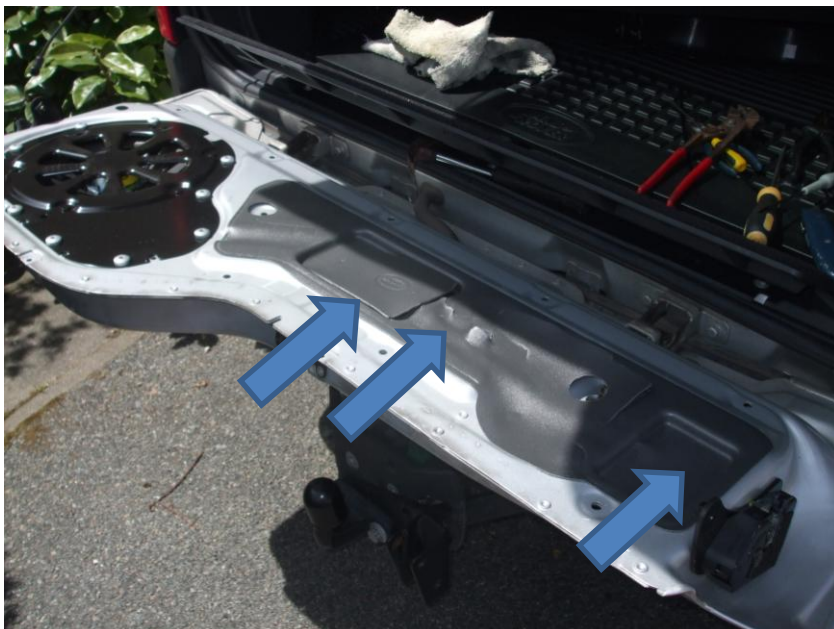
And now you should see this. The water shedder may need cutting as it is super stuck down. You'll have to make cuts in a number of areas

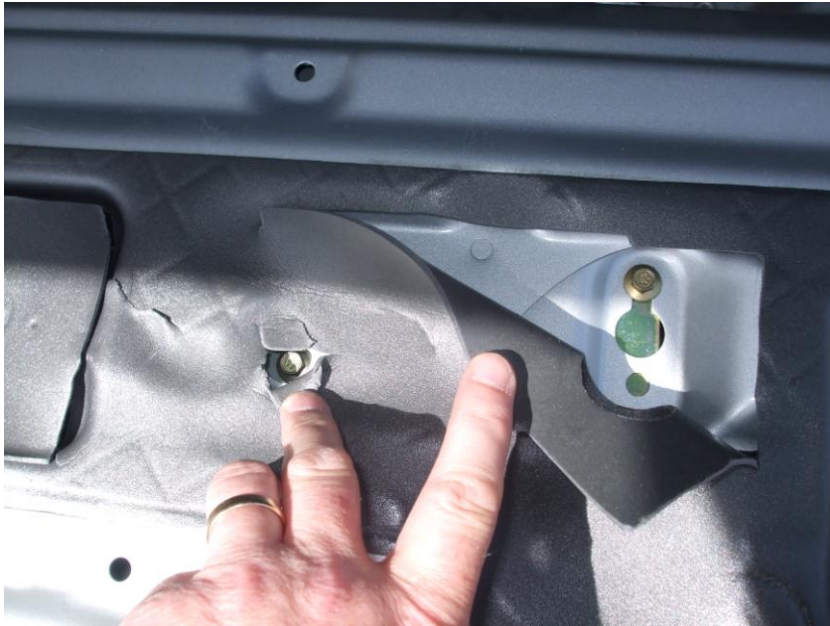
Partially loosen these two nuts. They are on keyhole slots so one or two turns is fine, no need to remove

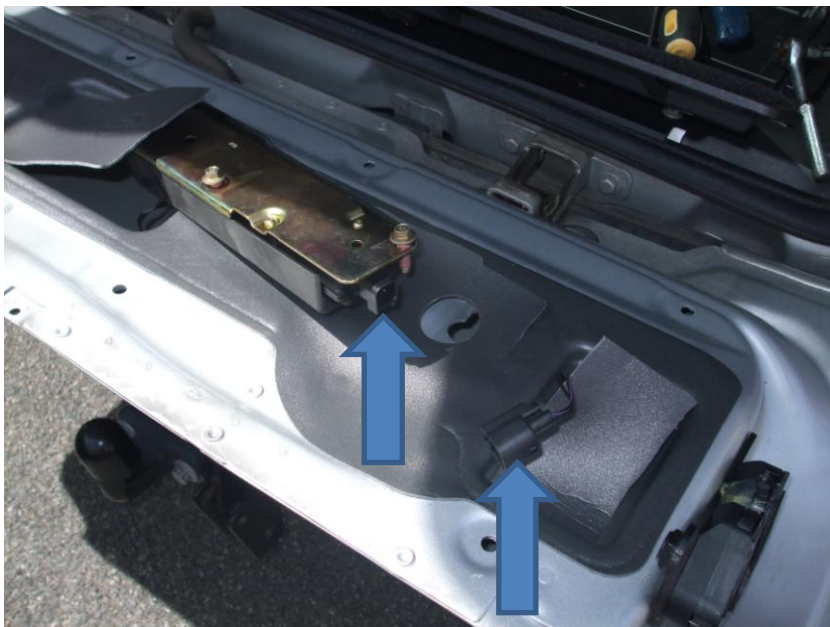
The actuator has to be removed through the large hole on the left (nearside), having first removed the electrical plug via the right-hand hole. The plug and socket are arrowed below

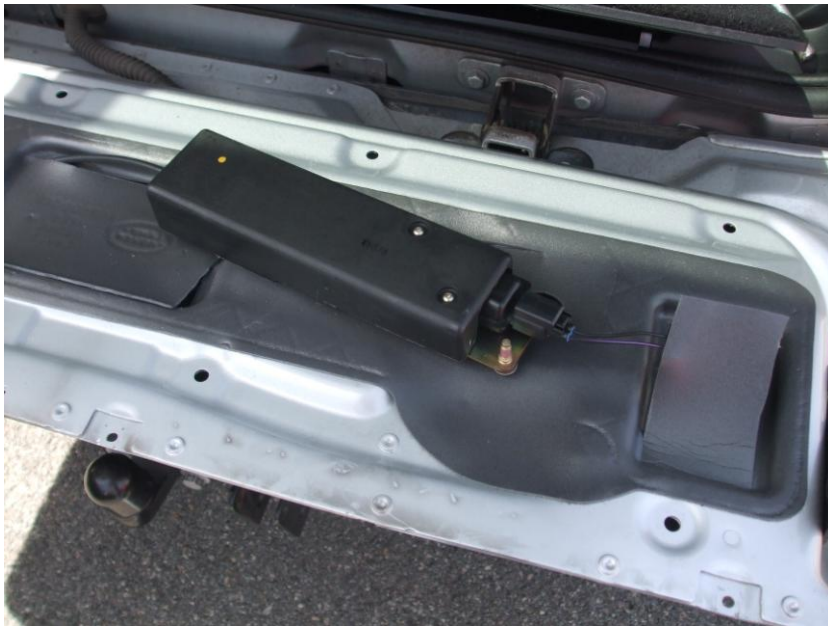
This is how it normally looks if it was inside the tailgate

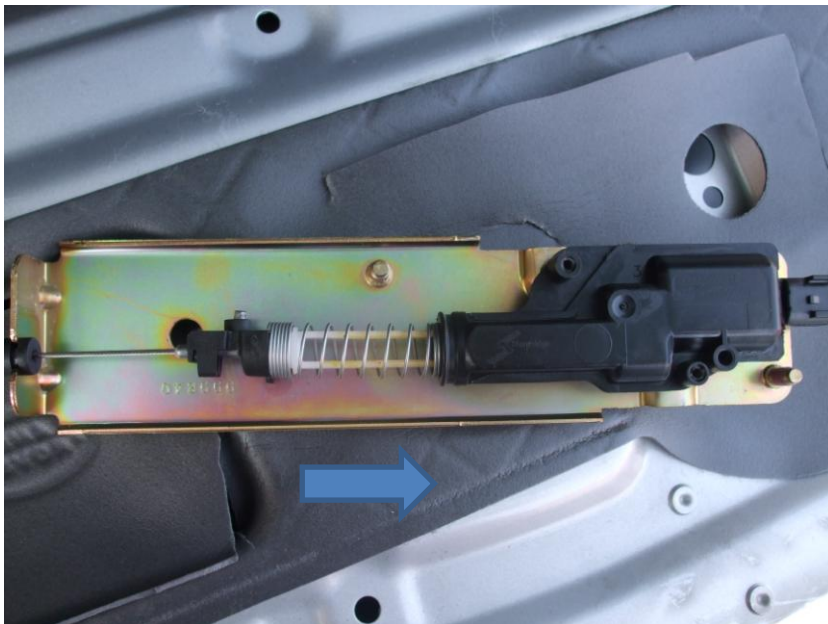
Remove the plastic cover by (two Torx screws). When the actuator operates the cable is pulled in the direction of the arrow

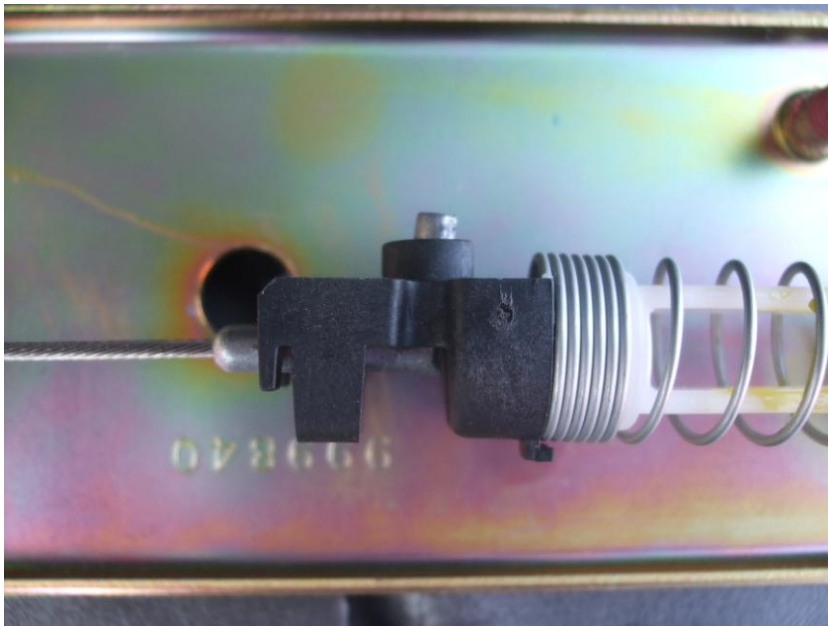
The cable has a right-angled alloy bit on the end, clipped into the plastic plunger

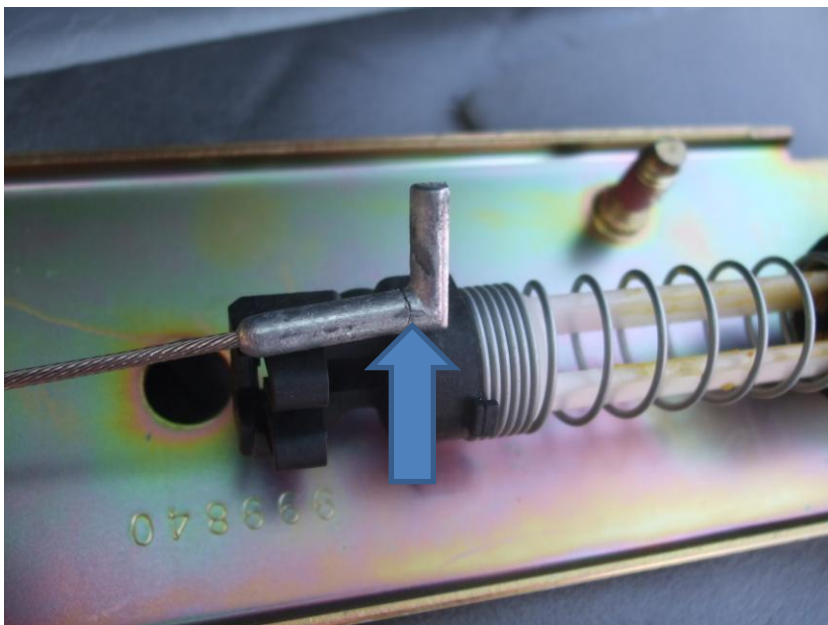
And the cable removed... with a crack in it on the right angle!!! The shock of the actuator pulling must cause fatigue

I hope this is of use to others; it appears that I was lucky to have found the crack before the inevitable happened.
