Removing the air temperature sensor

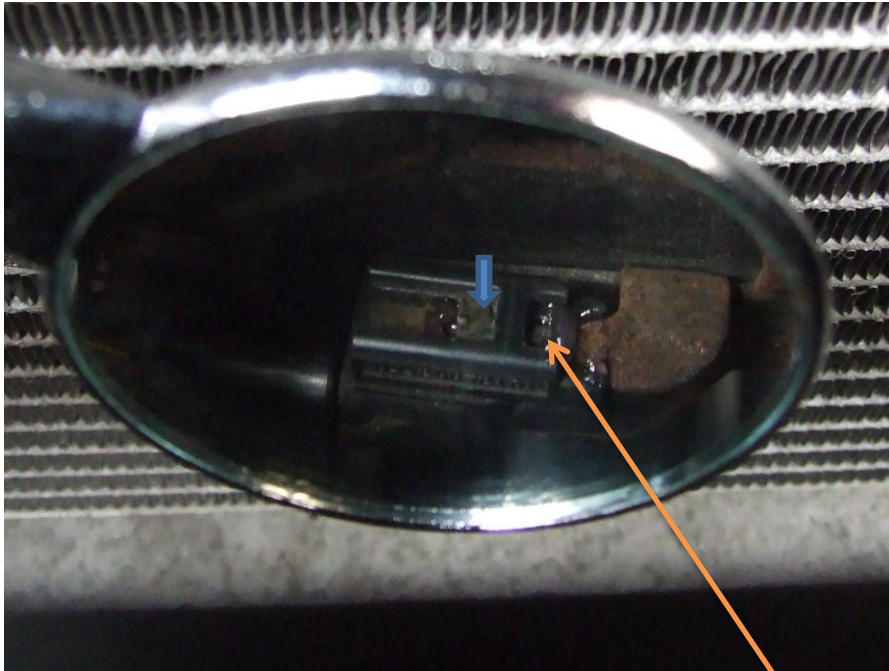
1. The sensor is behind the front bumper, looking with a mirror, it is clipped to a metal bracket.

There is a plastic tab that locates into a hole in the bracket, here (slightly obscured due to grease being used when refitting to aid future removal). This needs to be moved upwards by inserting a screwdriver between it and the bracket. There is a piece of plastic at the blue arrow, this snapped off...

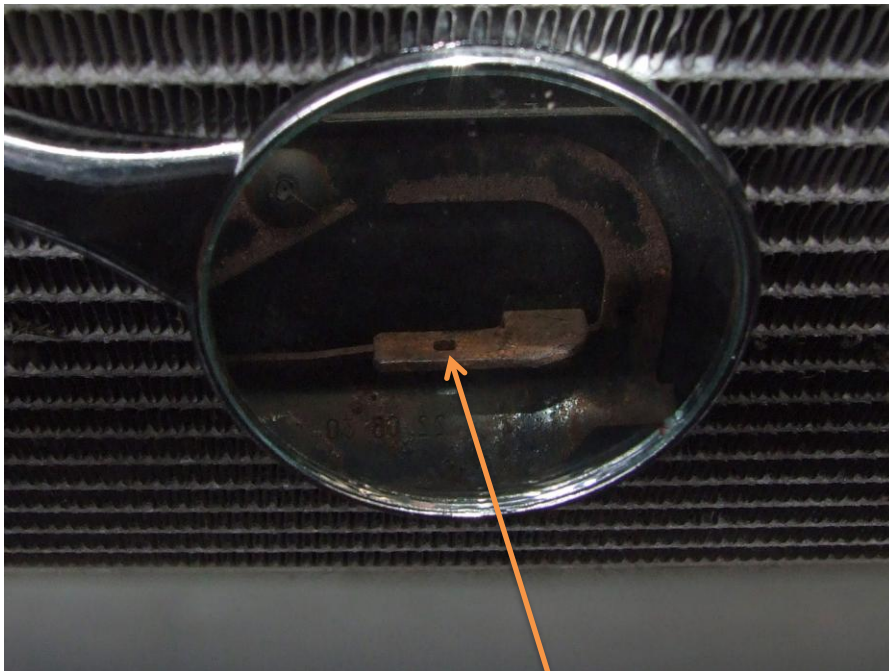
2. Slide the sensor to the left (towards the vehicle's offside, if RH drive), and off she comes.

The hole where the tab was can now be seen (no grease; the images were taken in reverse order and the grease added when the sensor was refitted).

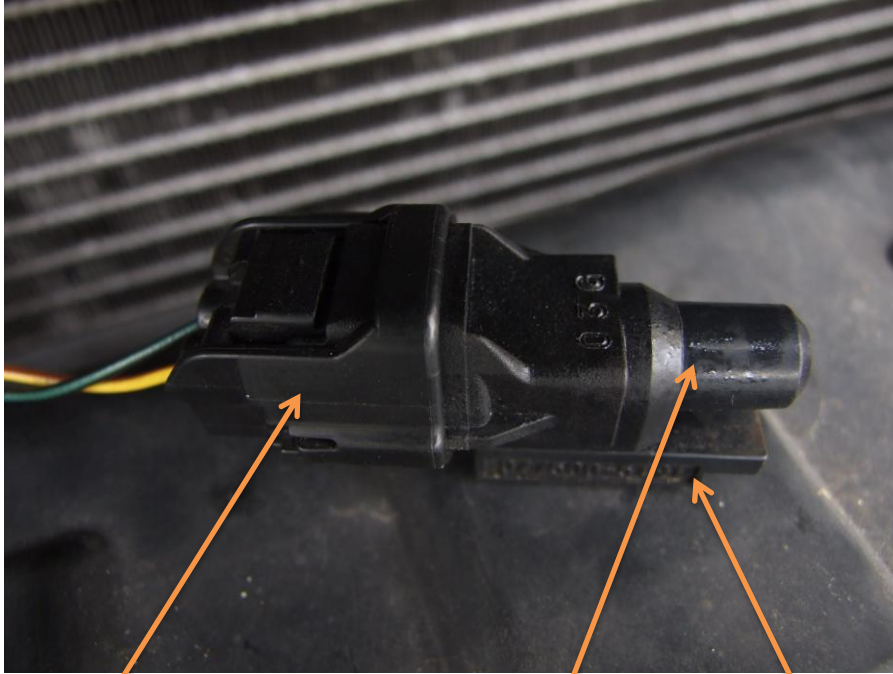
3. The sensor, removed and now upside down

This plug needs to come off

this is the sensor

this is the clip part, now underneath

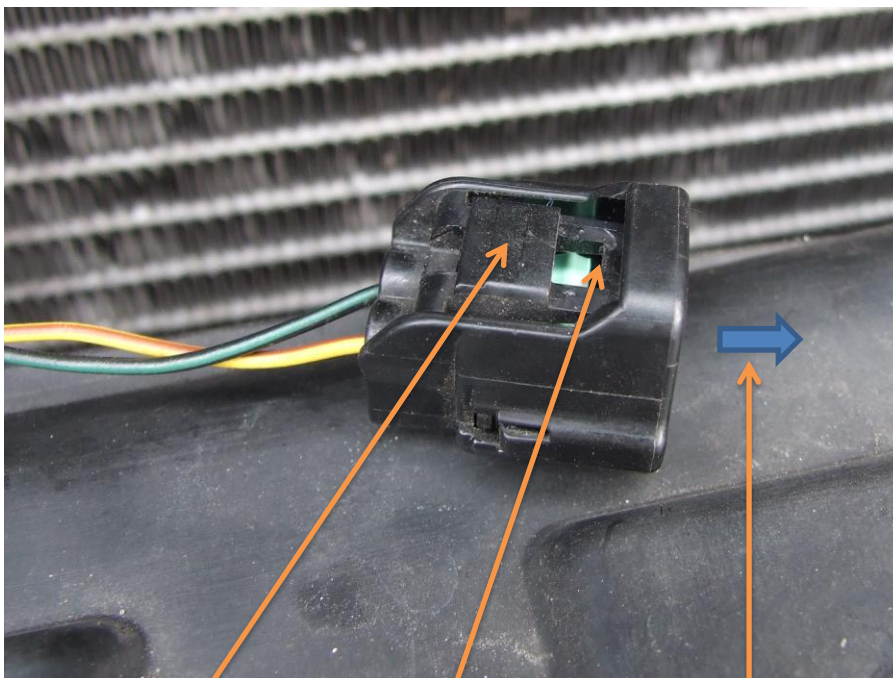
4. To separate the plug from the sensor

Push down here, this lowers this tab, and pull the sensor out
