TECHNICAL BULLETIN
 LTB00966NAS1
 23 AUG 2016

SECTION: 307-05

Transmission Control Switch (TCS) Illumination: Green Lights Inoperative

LR4 (LA)
Model Year: 2014-2016
VIN: 704668-840480
Assembly Plant: Solihull

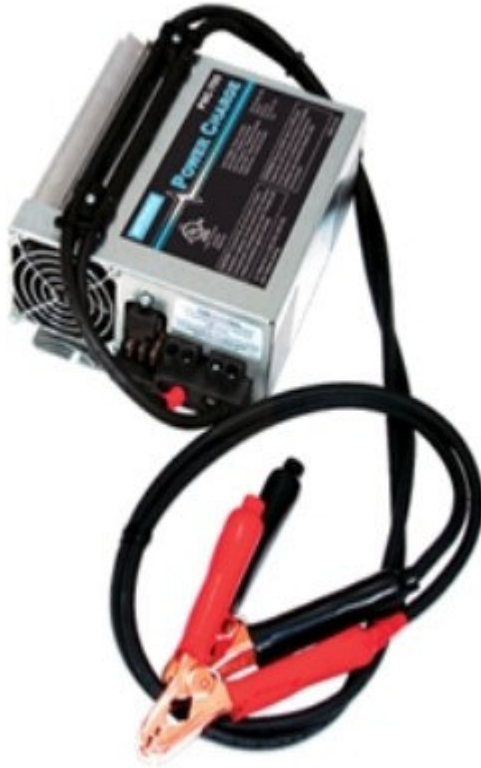
E192494

Jaguar Land Rover-approved Midtronics battery power supply

2. Connect the Jaguar Land Rover-approved Midtronics battery power supply to the vehicle battery.
3. Turn ignition ON (engine not running).
4. Connect the Jaguar Land Rover-approved diagnostic tool to the vehicle and begin a new session.
5. Follow the on-screen prompts, allowing the diagnostic tool to read the VIN, identify the vehicle, and initiating the data collect sequence.
6. Select **Service functions** from the Session Type screen.
7. Select the **Recommendations** tab.
8. Select **Run** to perform the '**Configure new module - Gear shift module**' option.
9. Follow all on-screen instructions to complete this task, ensuring all Diagnostic Trouble Codes (DTC) are cleared.
10. When all tasks are complete, select the **Session** tab and then select the **Close Session** option.
11. Disconnect the diagnostic tool and battery power supply from the vehicle.
