Water Leaks

General

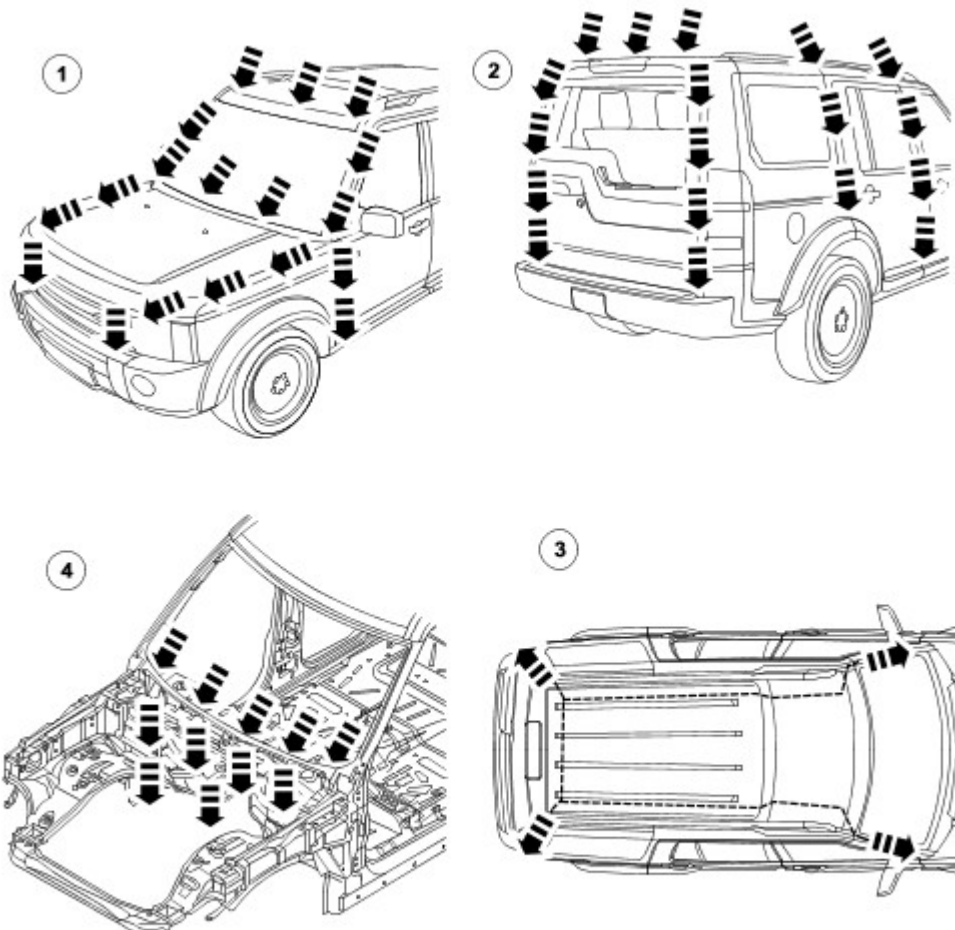
E56126

Water drainage system

Item	Part Number	Description
1		Water drainage, front
2		Water drainage, side and rear
3		Roof drainage
4		Engine compartment drainage

If a vehicle develops water leaks, then areas into which water is routed or drained should be checked first.
