# WORKSHOP

## DISCOVERY 3 PROJECT PART 5

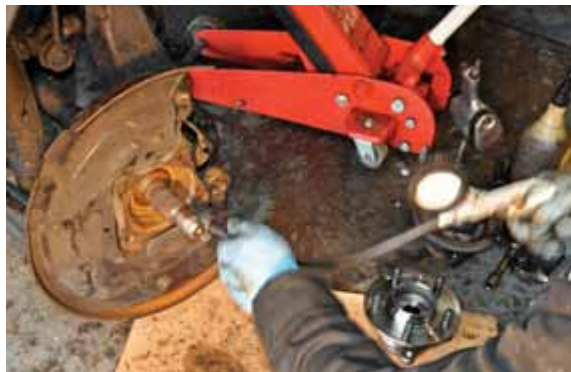
Here, Rob uses an air blower gun to get rid of the dust from the clean-up job, but a soft-bristled paintbrush would be just as effective.

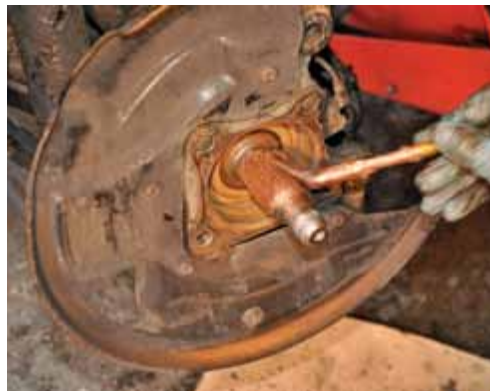
Coating the driveshaft in copper grease will ensure that it won't stick to the driveshaft and will make any future repair here much easier.

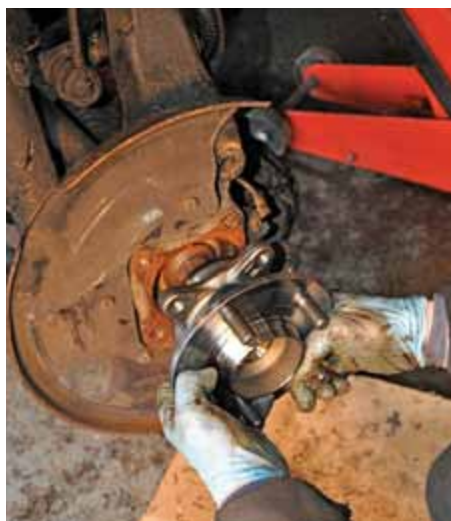
Disco 3 owners needn't worry about pushing out bearings or fret about pressing replacements in straight, because the job has been somewhat dumbed down to a straight swap of the complete hub and bearing assembly. So, making the actual repair is the quickest and easiest part of the job. This ease of replacement does sugar the pill of the assembly's £100 price tag a little.

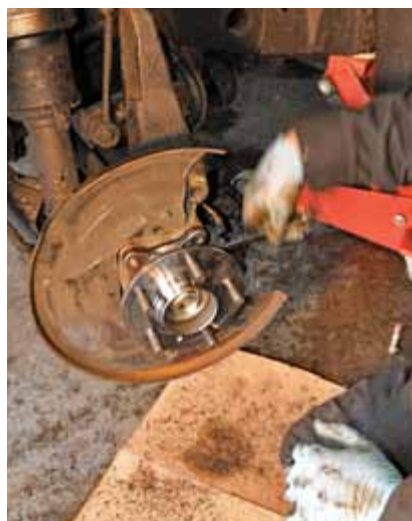
Rob gives the hub bolts' threads a coating of copper grease and tightens them gradually to bring the hub's flange in good and square.

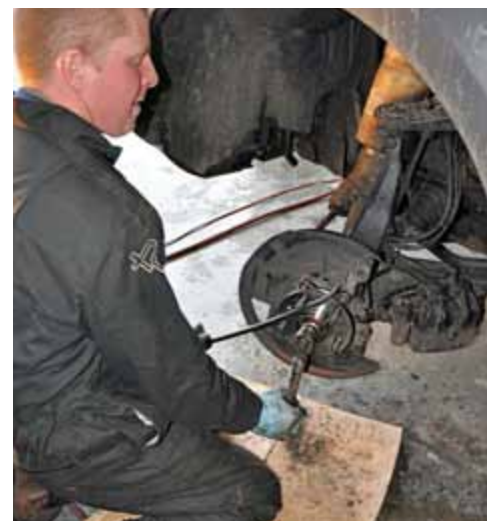
A brand-new nut is screwed on to the end of the driveshaft and is torqued up to 230Nm. This stake nut has a ring that is punched down into a groove in the driveshaft to prevent it from coming undone. It's common to see these straightened out and re-used, but the metal is then much weaker (having been work-hardened) and the potential for the nut coming loose is higher.

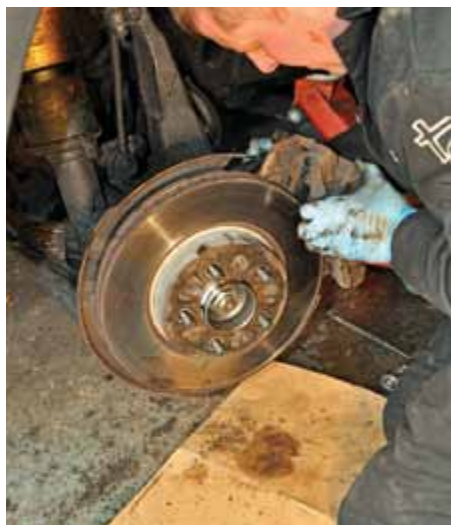
The disc and caliper go back on and, once both are bolted up, Rob checks that the disc turns cleanly by rotating it a couple of times.

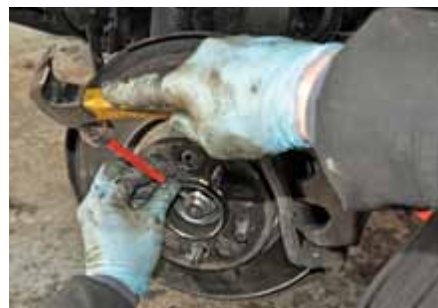
With all the bolts re-checked for tightness and torque, the stake nut is knocked into the groove in the driveshaft.

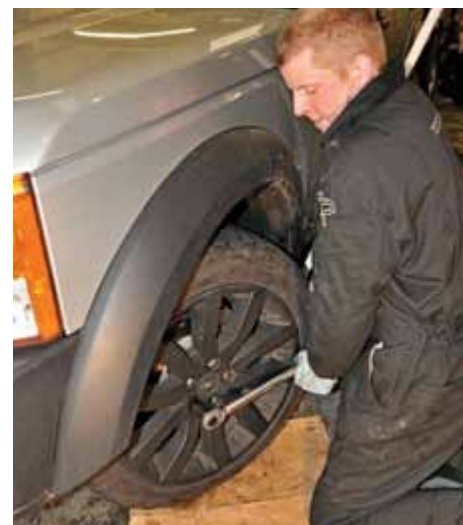
After replacing the wheel, there's no evidence of play; and a test-drive reveals a distinct lack of roughness from the nearside front wheel bearing. A successful outcome.
